Hayden Flour Mill Archaeology Update

Photos to accompany ACS update for Tempe website, March 16, 2007

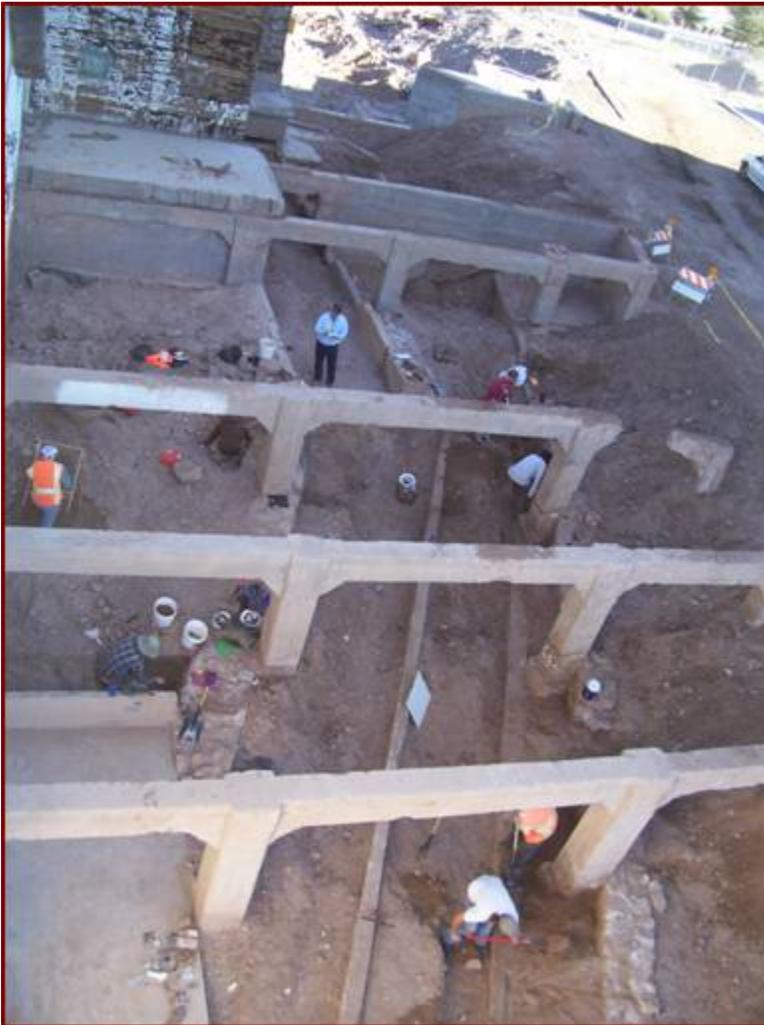
PHOTO 1

Caption Photo 1: Several alignments of the Hayden Canal head race and diversion ditch as viewed from the roof of the mill. The stone walls mark the earliest canal that was associated with the adobe building; the concrete edges mark later changes.

A number of exciting discoveries were made during the three weeks of excavation. Along the east side of the mill building, the field crew uncovered several walls that had directed water from the Hayden Canal in order power the machinery before electricity was available. Foundation walls for the original adobe mill building were also discovered, which demonstrated that the water which originally powered the mill had flowed inside the building along its eastern wall.

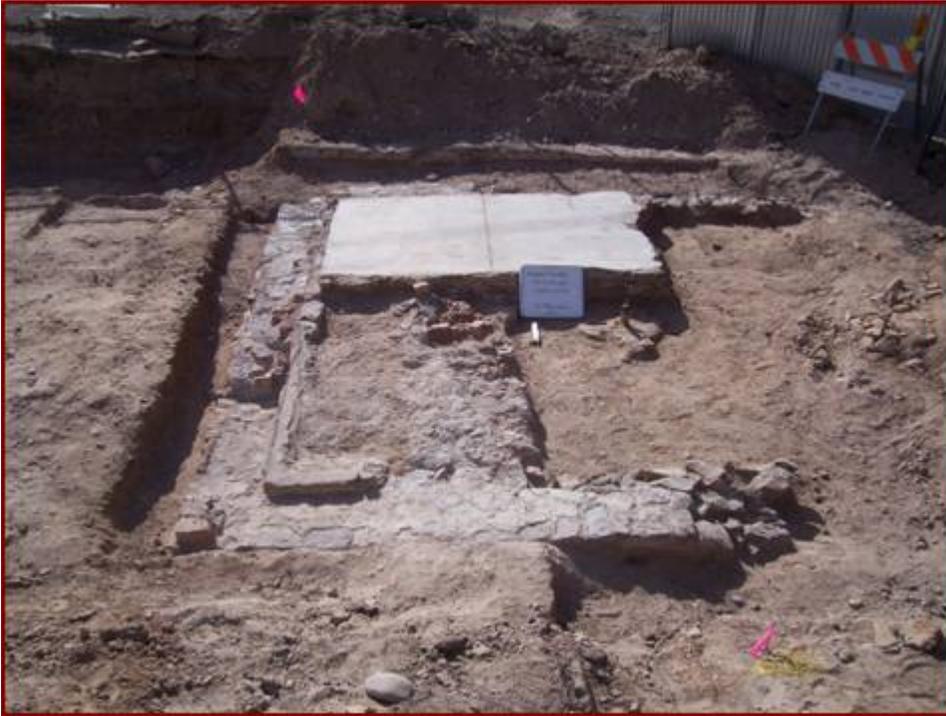
Photo 2

Caption for Photo 2: The foundation of the calaboose (jail) after excavation was complete.

ACS archaeologists learned that the foundation of the calaboose was more intact than had been expected. Historic coins were uncovered that could help to corroborate the structure's late 19th to early 20th century date with information on historic maps. Limited work (due to environmental safety issues) was done at the historic gas station on the south end of the site.

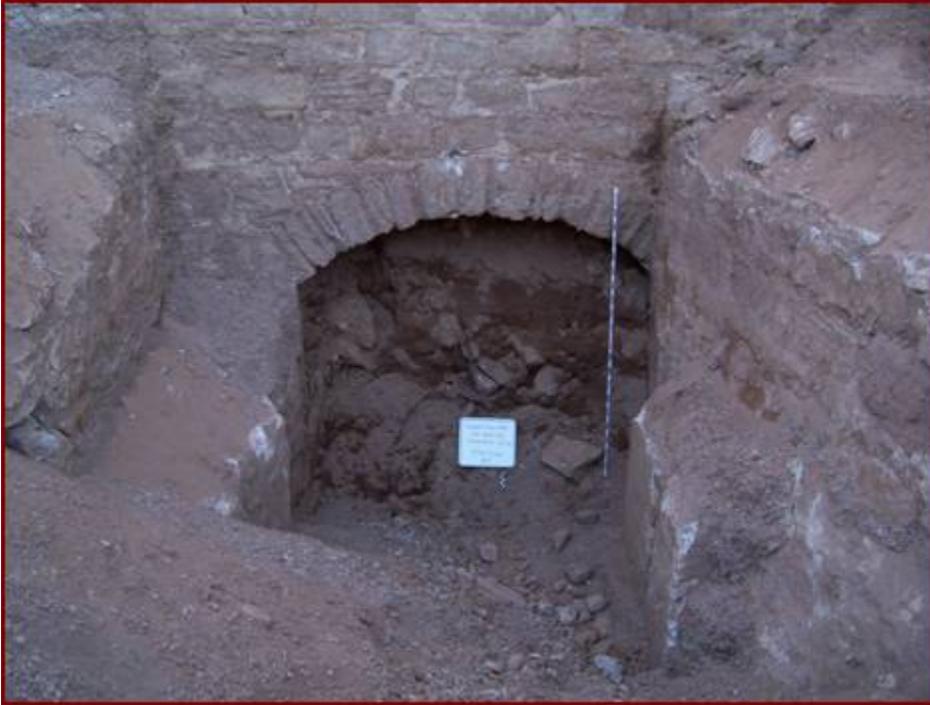
PHOTO 3:

Caption Photo 3: A view of the stone arch that archaeologists uncovered during excavation.
